India Mark II and India Mark III Borehole Hand Pump Variation Study in Uganda

Revision 3.7 | July 30, 2018 (Revised on May 11, 2021)

**Department of Mechanical Engineering
Ira A. Fulton College of Engineering and Technology
Brigham Young University**

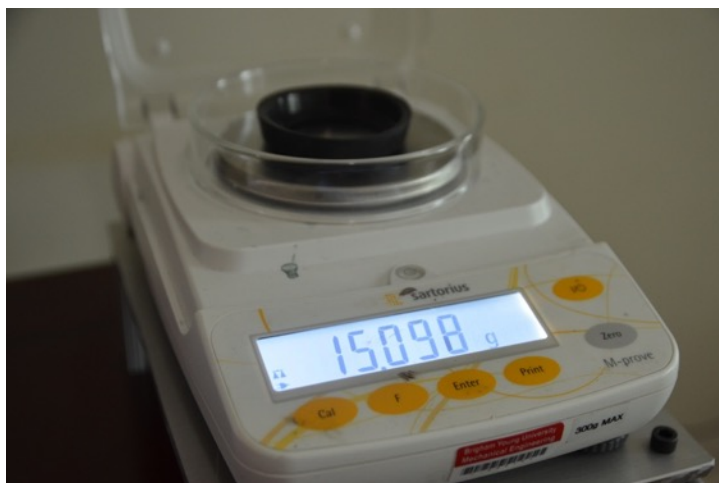
The Sartorius AY303 scale (see Figure A1.1) was used to measure seal weight with readability 0.001 g, repeatability 0.005 g, and linearity 0.005 g. The AY303 was powered using eight 1.5 V batteries to make the device portable. Before use, the scale was leveled using the adjustable legs and the built-in bubble level. Measures were taken to ensure that there was no airflow in the test environment, as the scale is sensitive enough to be affected by it. Also before use, the scale was able to sit for a short period of time while connected to the battery power supply (step 3 below). This resulted in a consistent readout.

Figure A1.1. Sartorius AY303 scale.

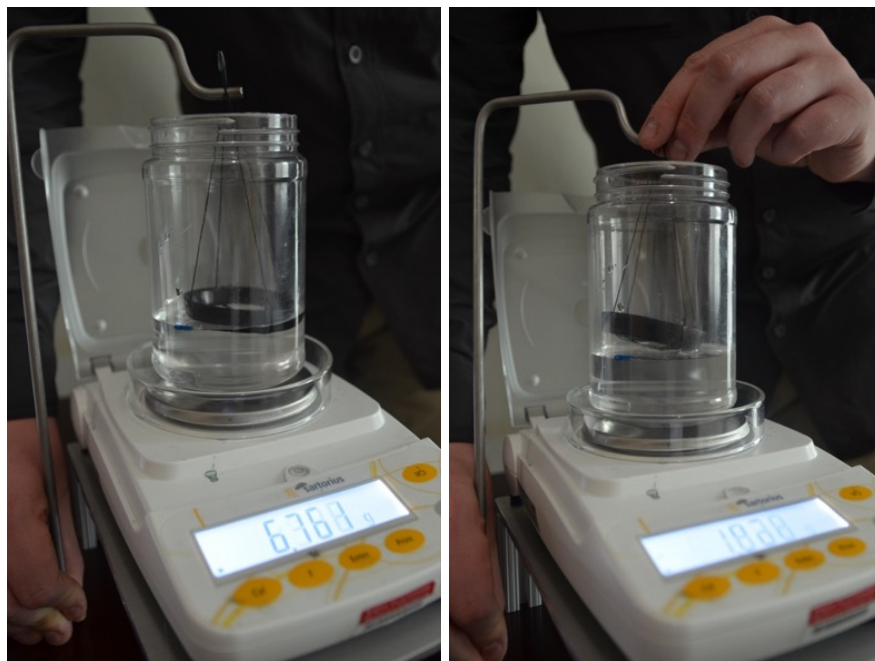
The water displacement method was used to measure seal volume. The Sartorius AY303 scale (Figure A2.1) was used in the set up. See Artifact A1 (Cup Seal Weight) for scale specifications and setup. To measure volume, the seal was held by a steadying rod and a seal basket to keep the seal from touching the side and bottom of the vessel (see Figure A2.1).

Figure A2.1. Setup of seal volume test.

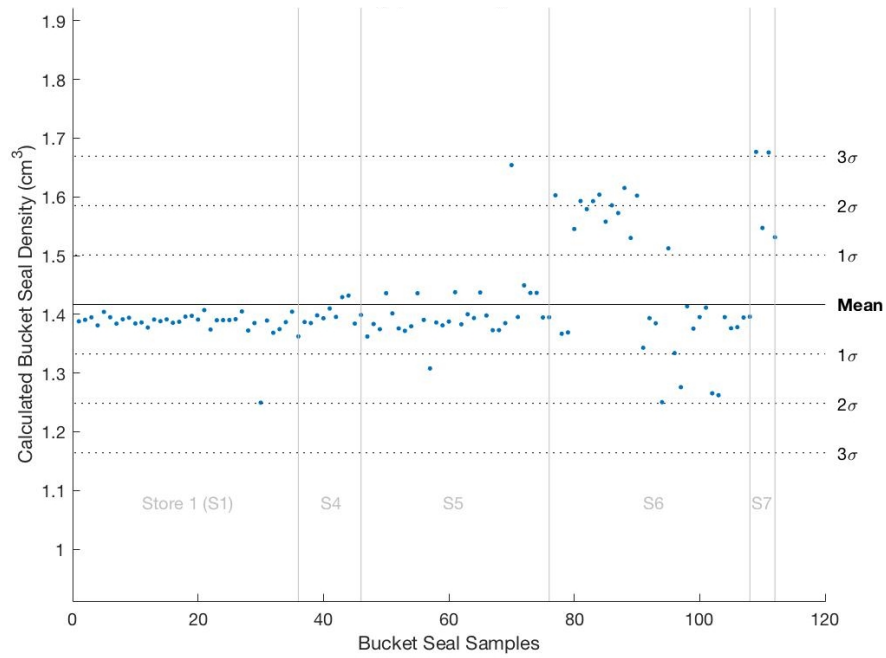
Figure A3.1. Cup seal density (calculated). Ordered as tested.

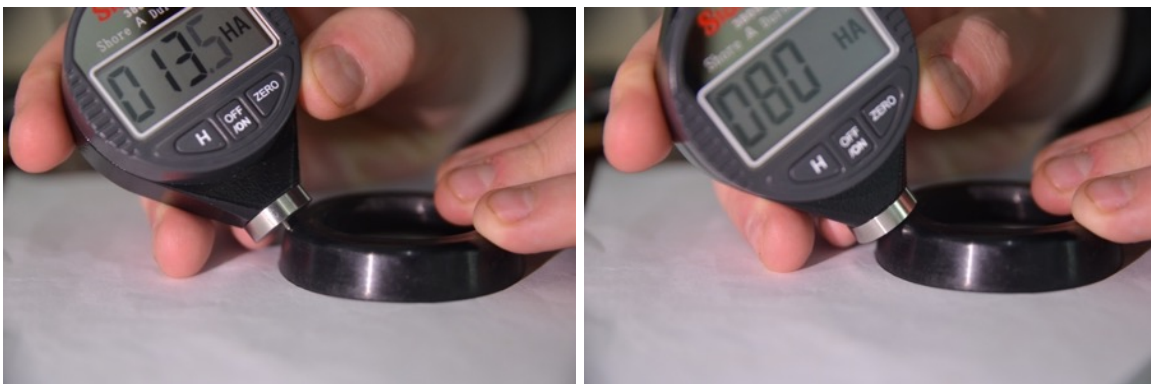
The Starrett Handheld Digital Durometer (H, Shore A Scale) was used to measure the durometer as shown in the photos below. The durometer is capable of a resolution of 0.5 H, deviation <1% in the 20-90 HSA range.

Figure A4.1. Measurement of seal edge.

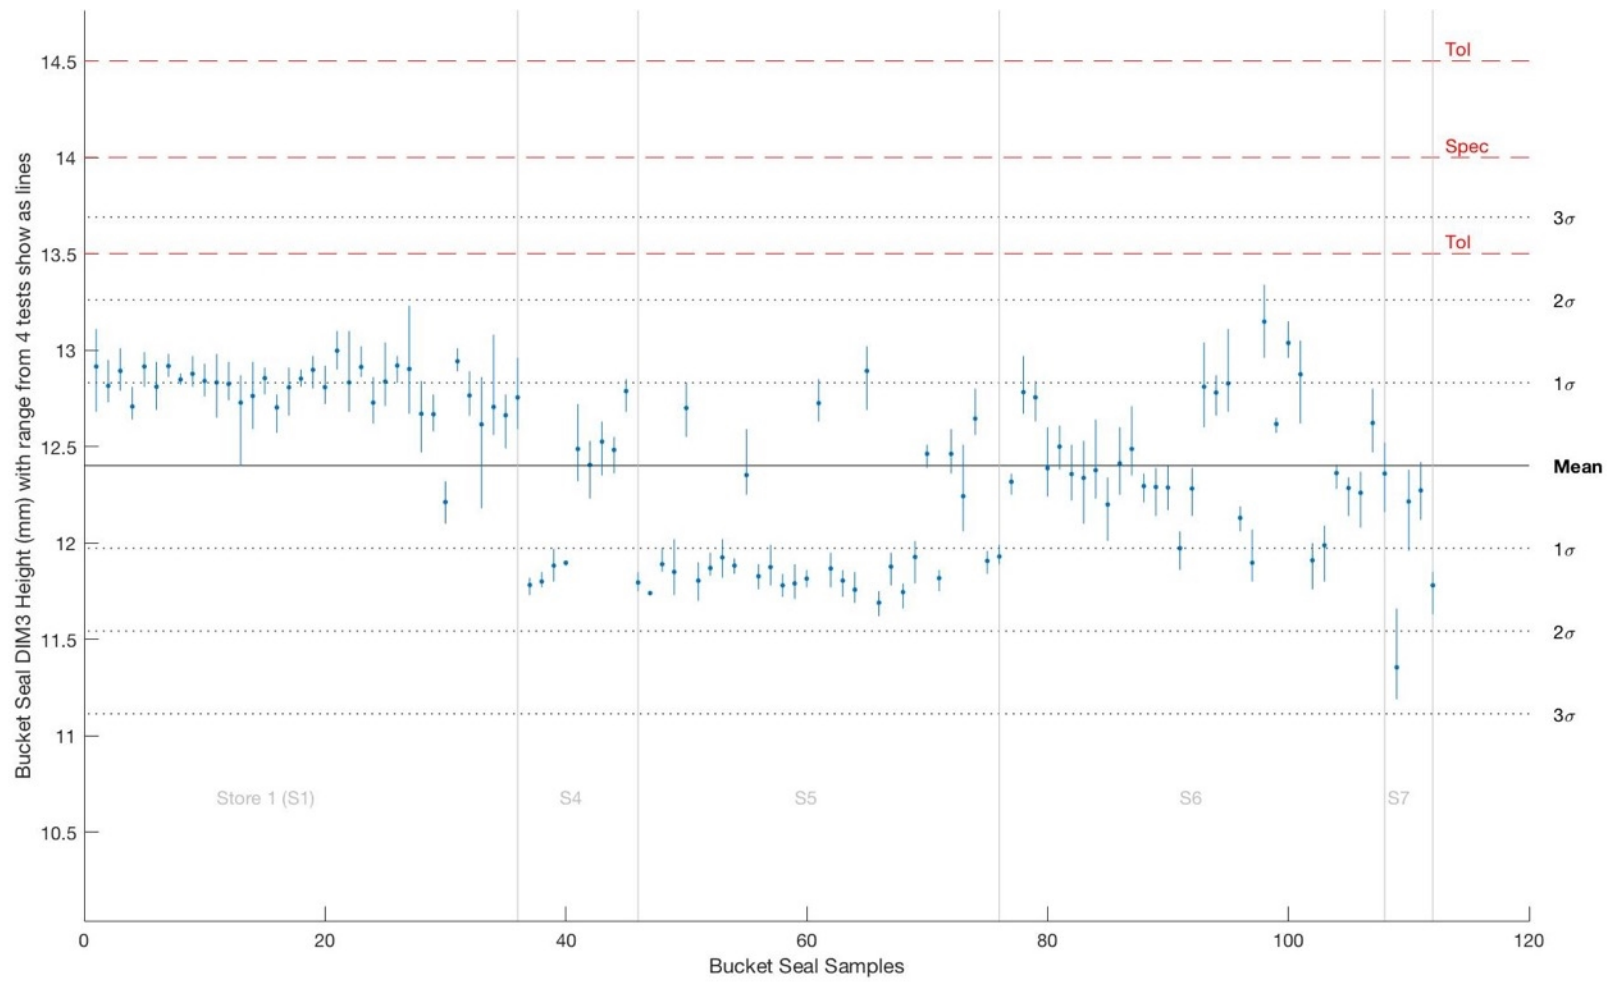
Figure A7.4. DIM 3: Cup seal height variation within sample. Four tests per sample.

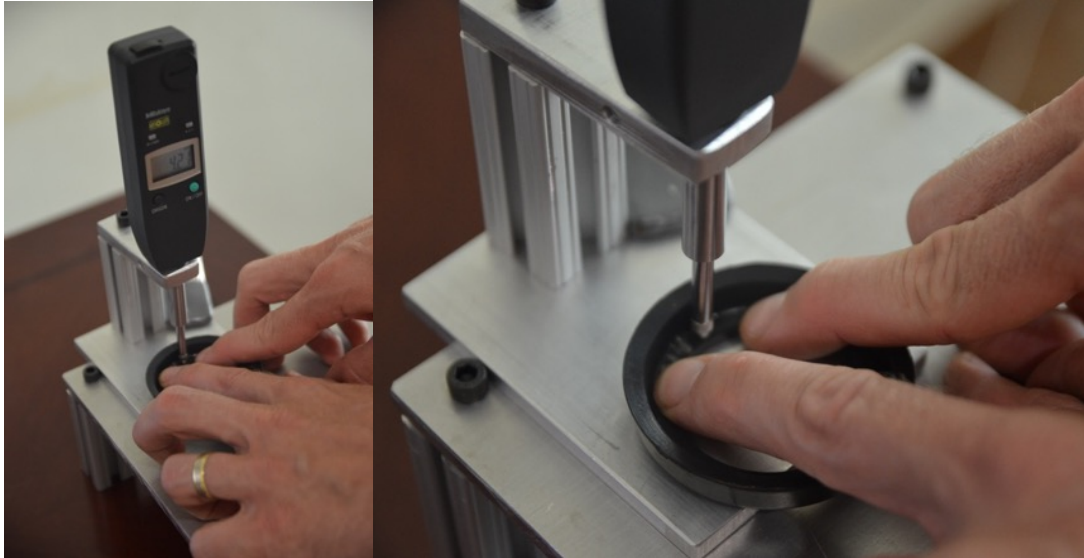
A Mitotoyo Digimatic Indicator (manufacturers part number 575-123) was used to measure the height of each seal in four places (at 0, $\pi/2$, π , $3/2\pi$, and 2π). The indicator accuracy is 0.02 mm, and a measurement force of 1.8 N. A custom stand was built to hold the indicator and provide a flat surface for the sample to rest on. Each seal was measured without the indicator tip touching the walls of the seal.

Figure A8.2. Measurement of the cup seal base.

1. Make sure that the instrument is at zero before taking measurement.
2. Place the needle of the indicator close to the edge of the seal as seen in image.
3. Read and record measurement.
4. Rotate the seal 90° and record measurement (do this 3 times for a total of 4 measurements).
5. Replace seal with new seal and repeat until done, keeping track of the order of seals.

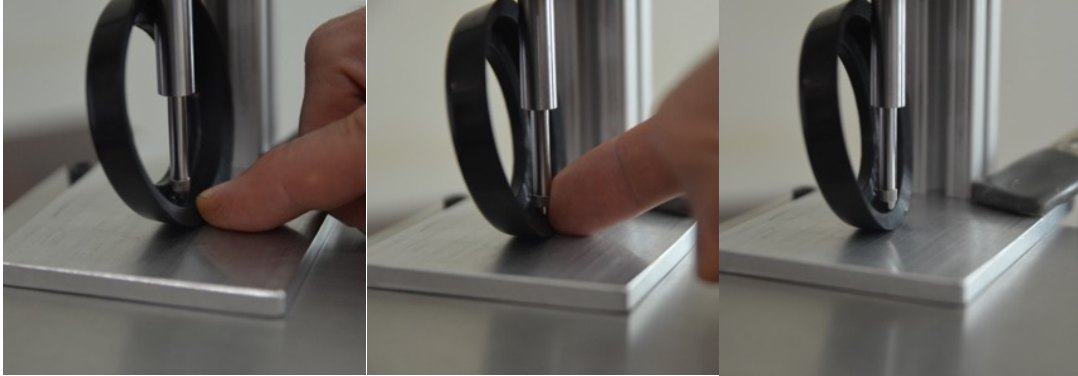
A Mitotoyo Digimatic Indicator (manufacturers part number 575-123) was used to measure the wall thickness of each seal in four places (at 0, PI/2, PI, 3/2PI, and 2PI). The indicator accuracy is 0.02 mm, and a measurement force of 1.8 N. A custom stand was built to hold the indicator and provide a flat surface for the sample to rest on. Each seal was measured with the indicator head near the base of the seal (as seen in the left photo) and near the edge of the seal (as seen in the right photo). The center photo indicated that the finger was used to line up the indicator with the edge for the wall thickness measurement at the edge.

Figure A9.2. Measurement of the seal wall thickness.

1. Make sure that the instrument is at zero before taking measurement.
2. Place the needle of the indicator close to the base as seen in above image on the left.
3. Read and record measurement. Place the needle of the indicator close to the edge of the seal as seen in middle and left images, using finger as a guide.
4. Read and record measurement.
5. Rotate the seal 90° and repeat steps 2-4 (do this 3 times for a total of 8 measurements).
6. Replace seal with new seal and repeat until done, keeping track of the order of seals.

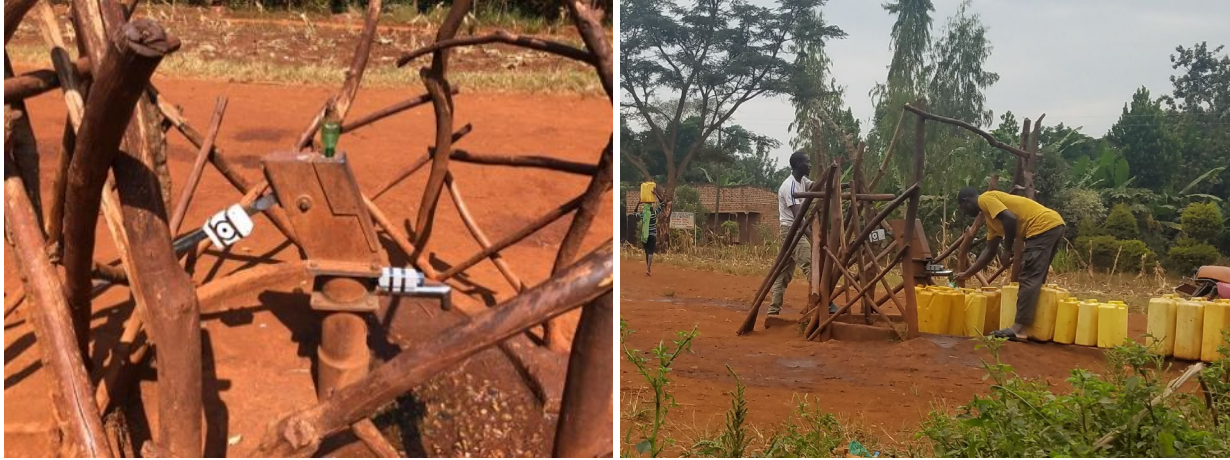
Figure A11.7. Borehole 1 near Jinja.

The borehole pump is an India Mark III and was recently repaired for a cracked coupler pipe (failed coupler shown in Figure A11.8). There is noticeable side to side pump handle movement, which has caused the top plate guiding the pump rod into the pipe to become worn. This causes significant lateral movement in the pump rod. It is believed by many that the lateral movement of pump rods eventually causes riser pipe failure as the PVC failure shown in Figure A11.9.

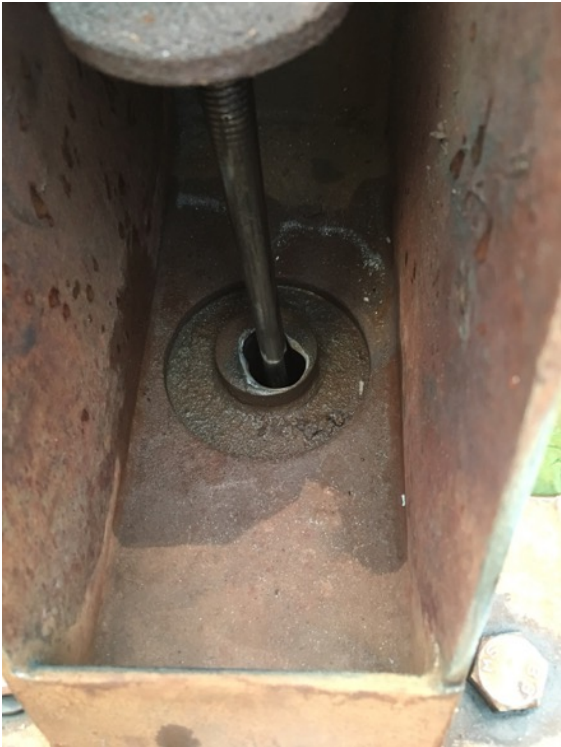
Figure A11.8. Borehole 1 near Jinja.

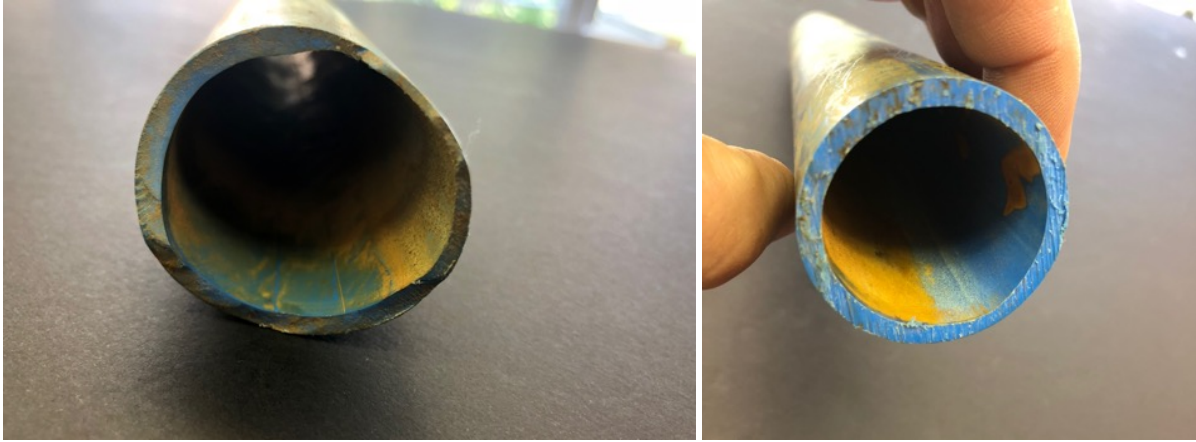
Figure A11.9. PVC pipe failure due to the pump rod being out of alignment.

PVC pipe fails at a high rate with vertical cracks, wear from side-to-side pump rod movement and wear from worn or missing pump rod gaskets.

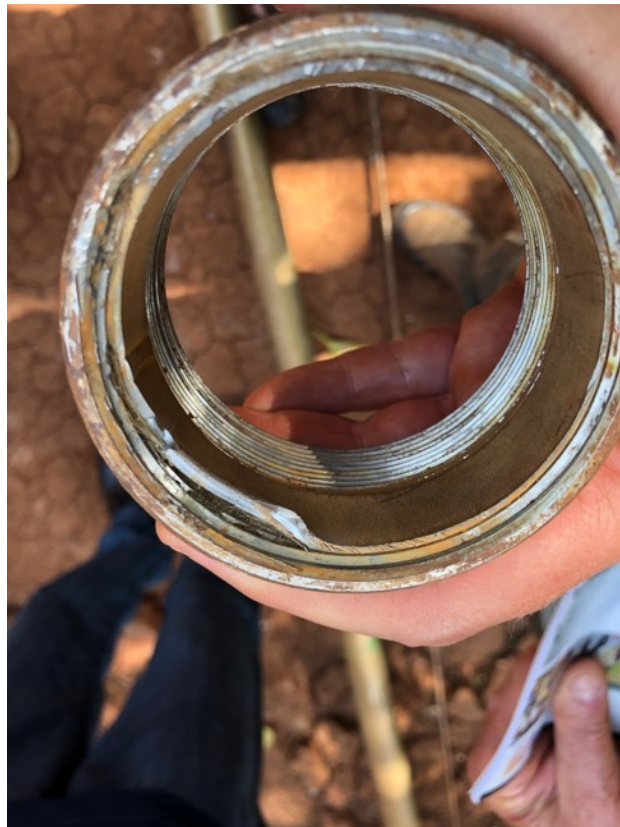
Figure A11.10. Failed riser pipe coupler.

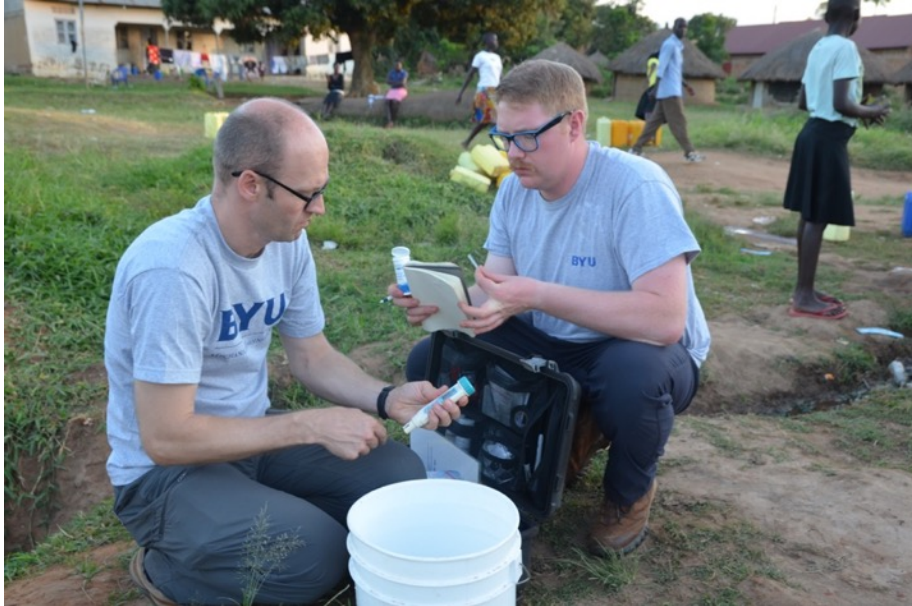
Figure A12.1. Measuring pH values.

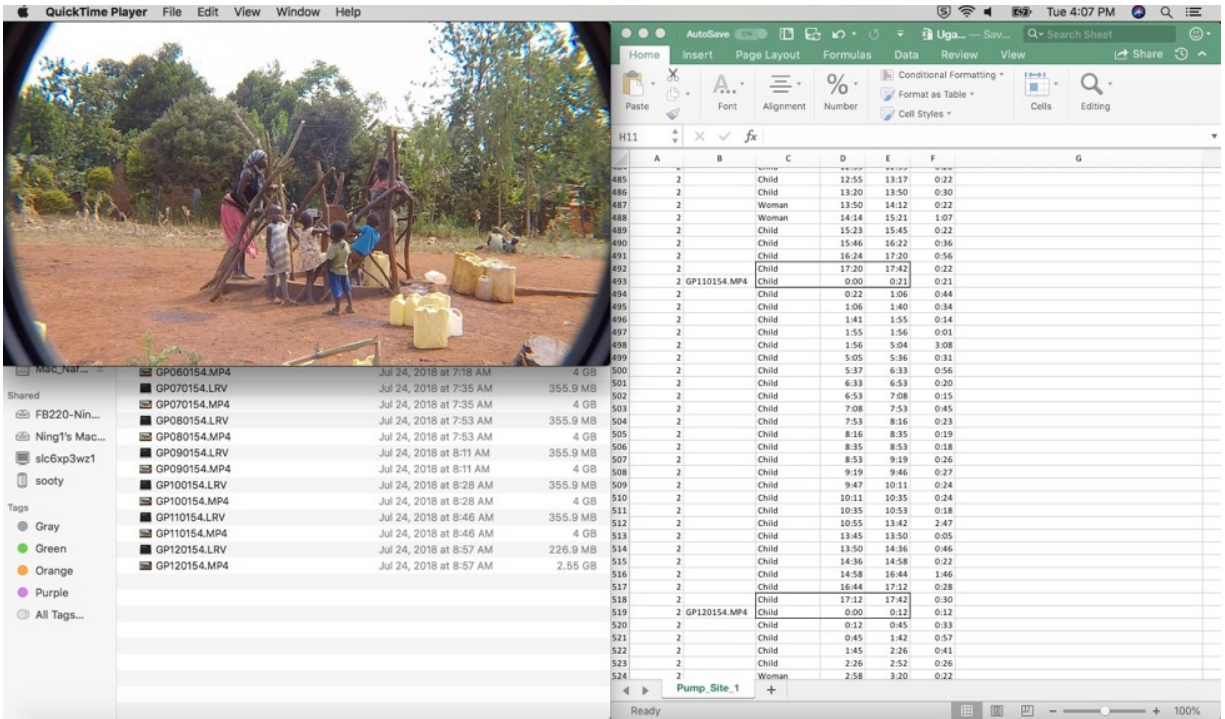
Figure A20.2. Gender analysis for borehole 1.

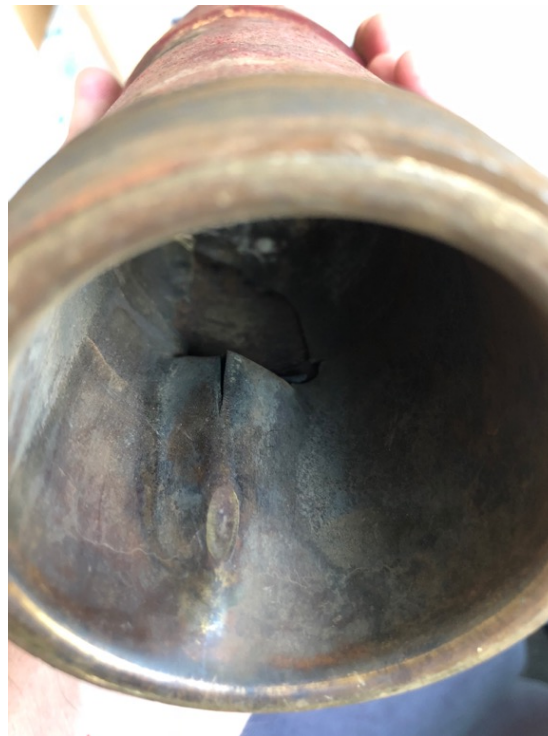
Figure A24.1. Failed pump cylinder copper lining.

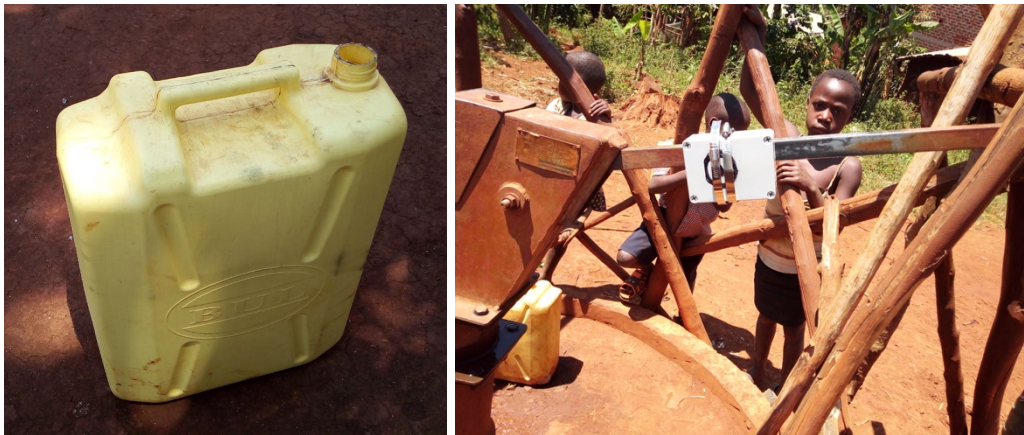
Figure A28.2. Jerry can used for test and placement of pump sensor.
